“Comparing the current impact of the Van Earthquake to past earthquakes in Eastern Turkey”

CEDIM Forensic Earthquake Analysis Group – Report #4

Status: Wednesday November 2nd, 2011, 18:00 Central European Time

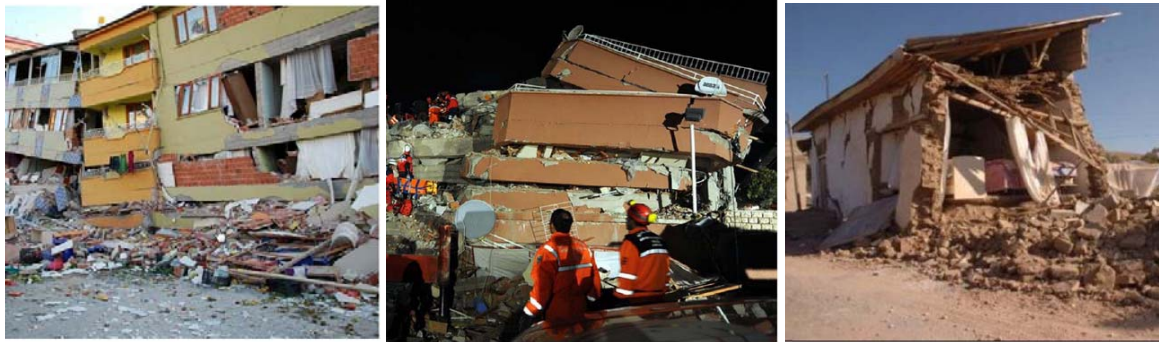
Figure 6: Soft storey collapse (left, gazetevatan.com); Pancake Collapse (central, fotogaleri.ntvmsnbc.com); Rural damage (right, gazetevatan.com)

Soft storey collapse regularly occurs in Turkish apartment buildings with the bottom storey having a higher storey height than the storeys above it, providing extra height for shops or for carparking. Concrete frame buildings with concrete flat slabs of three to seven stories collapsed in some cases around the urban centers of Ercis and Van.

Pancake collapse can occur where the columns of each level fail. Pancake collapses of the lower part and of the entire building and so-called outspread multi layer collapses can be seen in photos provided. As observed after the 1999 Izmit earthquake, many of the concrete floors did not remain intact within the collapse structures. Large voids in upper stories when only partly collapsed, but mostly very dense collapse structures lead to many casualties. This is the most fatal type of collapse with approximately 10x more injuries occurring in a total collapse, than in other forms of buildings beyond repair.

In addition, weak column-beam connections and weak building materials such as understrength concrete have had a huge impact on the building damage ratios.

Rural damage: People live typically in one storey buildings with tin roofs where this is only a small chance for fatalities even in case of heavy damage or collapse. Cattle was held in buildings with heavy concrete roof, lots of losses. The pictures in the KOERI reports show villages that seem to be quite devastated, but as said not too many fatalities.

Urban damage: Many modern buildings did quite well but typically older ones collapsed. The typical damage forms are well documented in the KOERI reports on the web. There have been weak first storey collapses (soft storey collapse) as well as pancake collapses that have been seen.

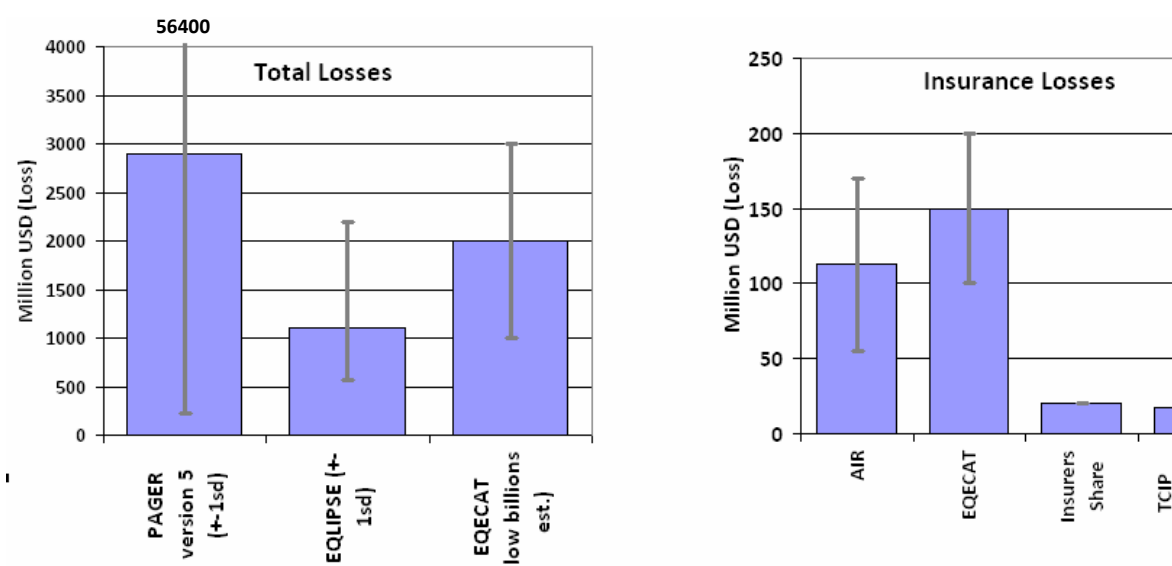
Figure 7: Economic Loss Estimates from various agencies (left); and Insurance Loss estimates from various agencies (right)

Total economic damage is estimated in the low single-digit billion USD from EQECAT CatWatch mimicking the PAGER model estimate (as reported on in the past CEDIM reports). Although this is 1/10th of the 1999 Izmit earthquake, it also should be noted that this earthquake is in a region around 4 times poorer (GDP-based) than Izmit.

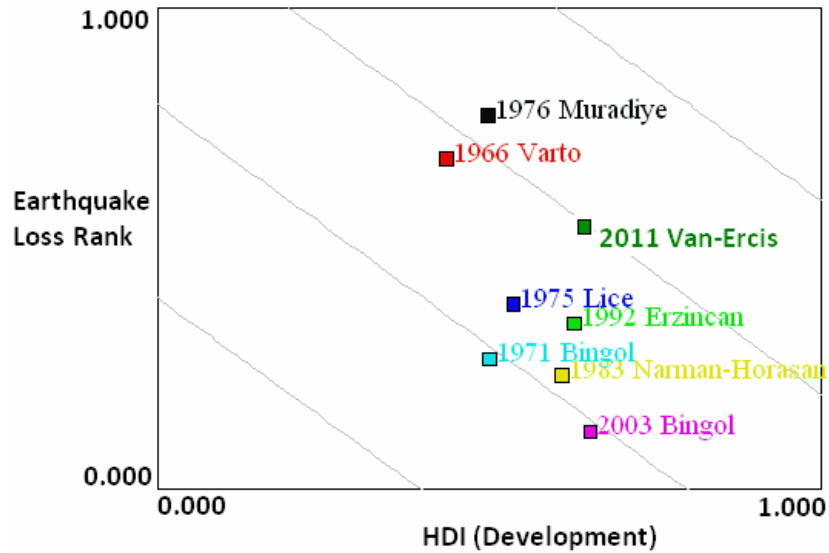
Figure 17: Scatterplot of Earthquake Physical Loss vs. HDI score for each of the provinces affected by the historic earthquakes in eastern Turkey similar to the 2011 event

Figure 17 shows a scatterplot with the Earthquake Loss Score shown on the vertical axis and HDI scores on the horizontal axis. The earthquakes in the bottom right have the least physical impact corresponding to higher capacities in the affected community according to the HDI values at the time of the earthquake occurrence, while the earthquakes in the upper left have the highest physical impacts corresponding with relatively lower capacities in the affected communities. It can be seen that the 2011 event has an impact greater than all but the 1966 Varto and 1976 Muradiye of the Eastern Turkey earthquakes in the last 50 years.
